Erosion Mitigation

Team Site Walk Report
August 2023

Site Walk – July 29, 2023

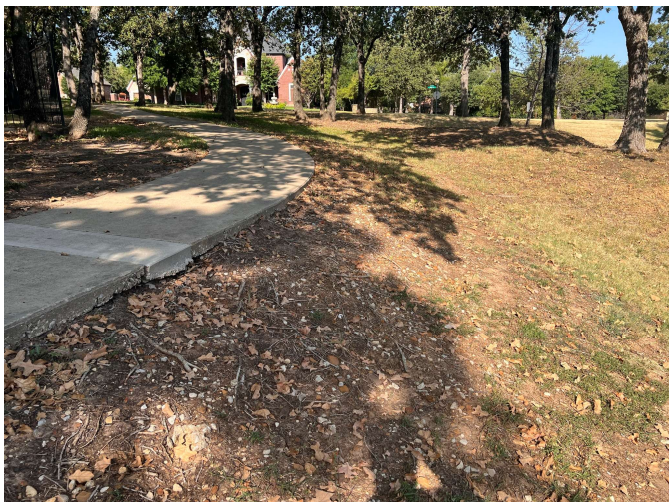
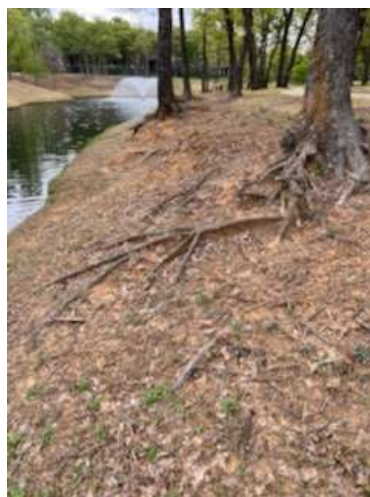
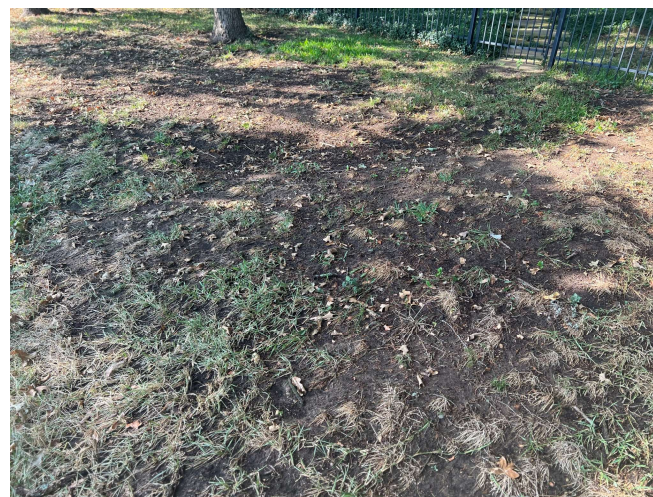
9 – Southwest Upper Pond Area

Priority Areas requiring immediate attention represent potential safety hazards and were showing clear evidence for causing destruction to physical infrastructure – sidewalks, trees and plantings and underground piping. These areas include **2, 5, 6, & 9 on map**

Photos are of both sides of sidewalk that shows the effects of run-off from water travelling underground from the Kinsale Drive area then washing up to the surface then travel on the surface down to the lower pond. This area drops off steeply exposing sidewalk underpinnings. Also represents safety (tripping) hazard.

Potential Solution: Excavate and install french drains on the outer side of the sidewalk, bringing system under the sidewalk then down the slope to drain into the lower pond. Construct stone retainer wall on pond side several feet away from and adjacent to sidewalk in order to level-off the area.

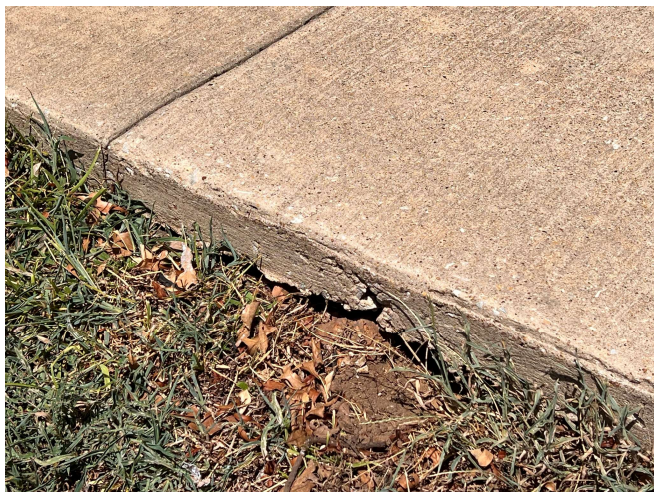
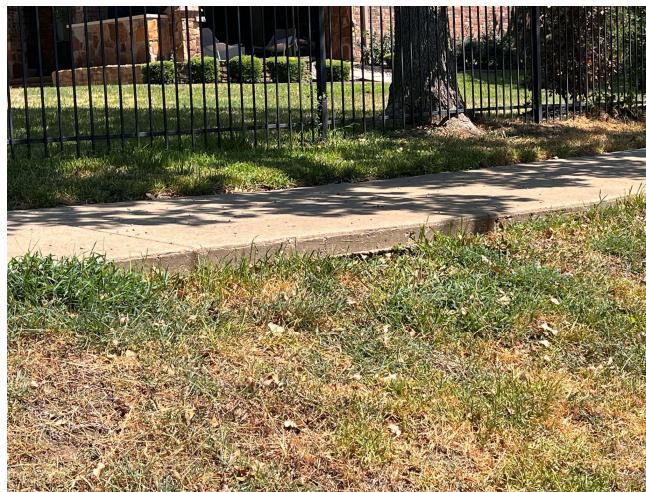
2 – Southeast Middle Pond Area

Photos are of the area on pond side of sidewalk that drops off steeply exposing sidewalk underpinnings. Erosion caused by water collecting from adjacent homes and common areas. Also represents safety (tripping) hazard.

Potential Solution: Construct stone retainer wall on pond side several feet away from and adjacent to sidewalk in order to level-off the area. This area could potentially serve as a future seating/viewing area once constructed.

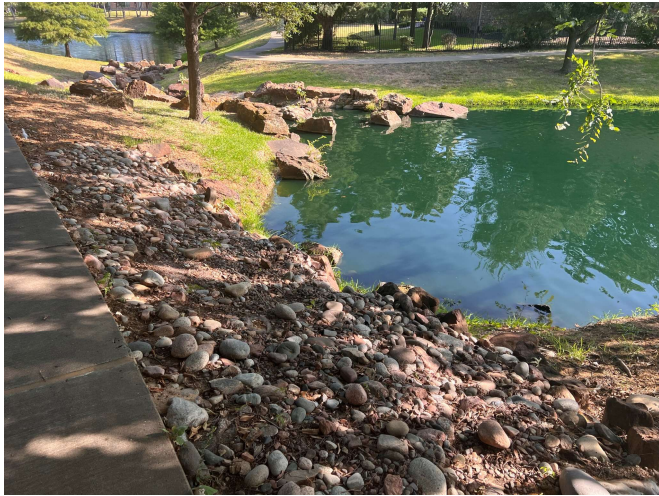
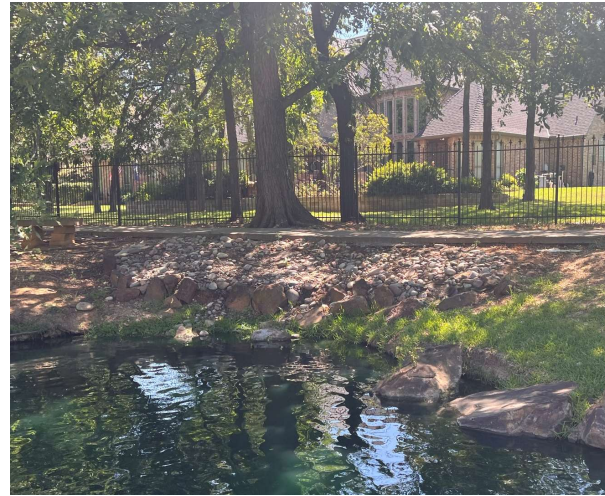
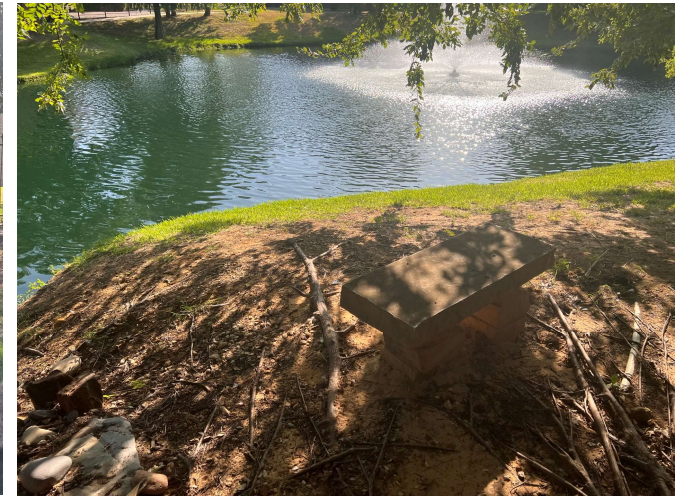
5 – Northwest Upper Pond Area

Photos are of the area on pond side of sidewalk that shows a former attempt to prevent erosion using river rock. This area drops off steeply exposing sidewalk underpinnings. Represents safety (tripping) hazard.

Potential Solution: Install large boulder rocks (similar to boulders already in this area) to build up to near level. Fill with stratified layers of large to small sized crushed stone (bottom to top). This area could potentially serve as a future seating/viewing area once constructed.

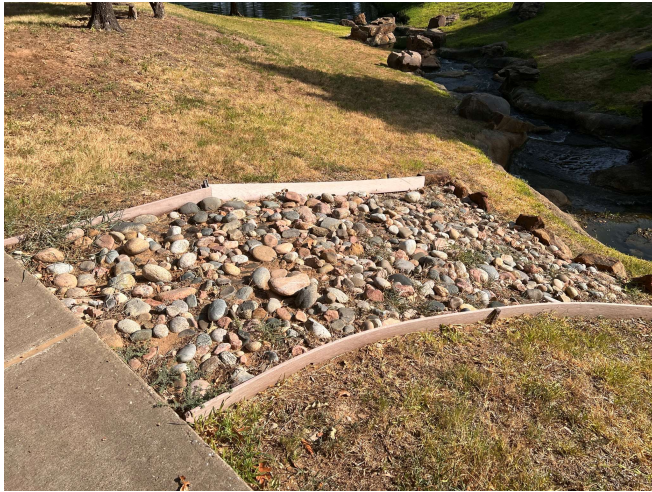
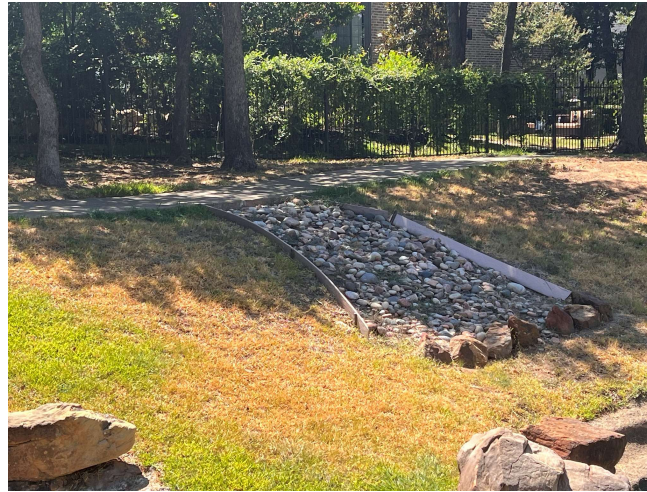
6 – Southwest Middle Pond Area

Photos are of the area on pond side of sidewalk that shows a former attempt to prevent erosion using river rock and wood boards. This area drops off steeply exposing sidewalk underpinnings. Represents safety (tripping) hazard.

Potential Solution: Install large boulder rocks (similar to boulders already in this area) to build up to near level. Fill with stratified layers of large to small sized crush stone (bottom to top). This area could potentially serve as a future seating/viewing area once constructed.

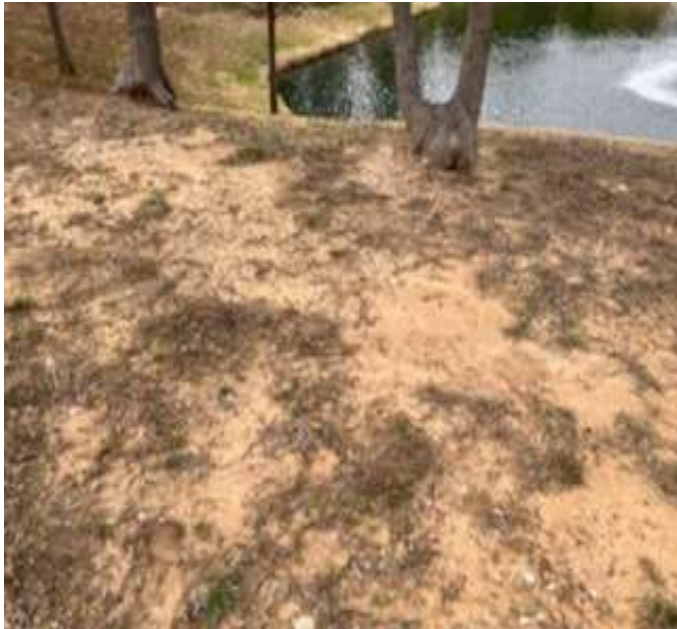
1 – East Middle Pond

Near Term Areas requiring attention in the next 1-3 years were considered potentially less hazardous and less destructive to physical infrastructure. These areas include **1, 3, 4, 7 & 8 on map**
