Erosion Mitigation

Team Site Walk Report
August 2023

Site Walk – July 29, 2023

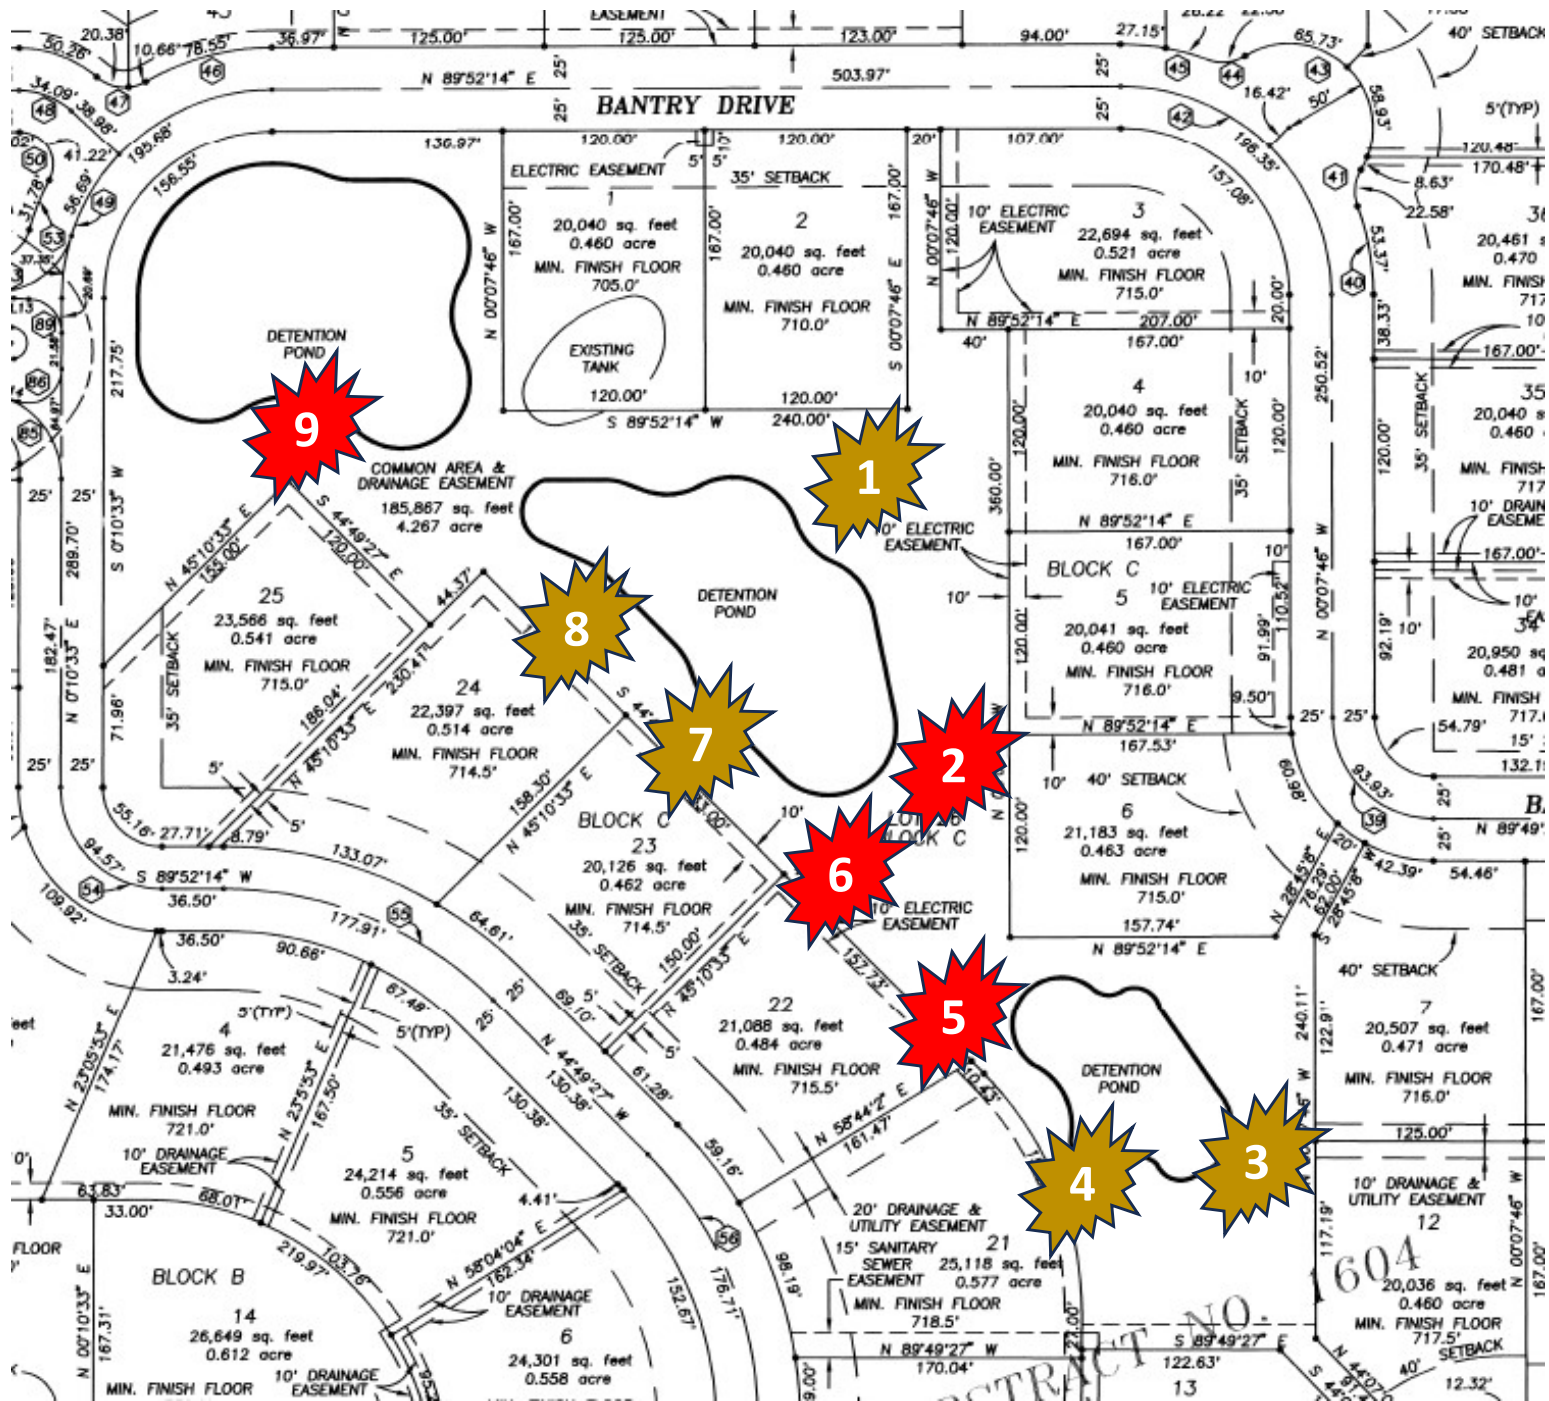
Priority Areas requiring immediate attention represent potential safety hazards and were showing clear evidence for causing destruction to physical infrastructure – sidewalks, trees and plantings and underground piping. These areas include **2, 5, 6, & 9 on map**

Near Term Areas requiring attention in the next 1-3 years were considered potentially less hazardous and less destructive to physical infrastructure. These areas include **1, 3, 4, 7 & 8 on map**
